# LOW CYCLE THERMAL FATIGUE AND FRACTURE OF REINFORCED PIPING

**W.J. O'Donnell, J.M. Watson**

## ABSTRACT

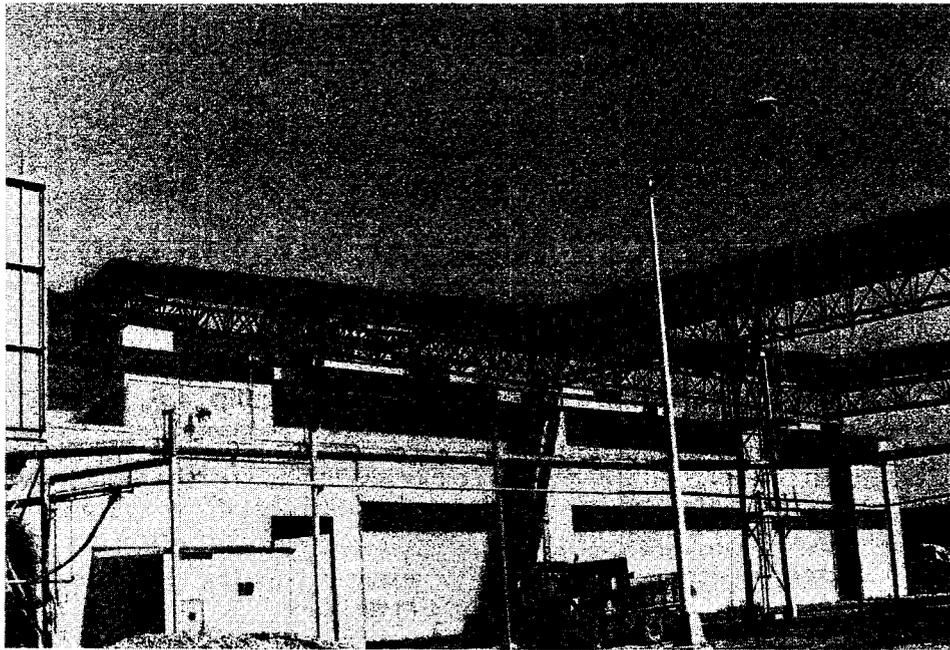
Fig. 1 - North duct viewed from just north of baghouse. Damaged south duct can be seen in background.

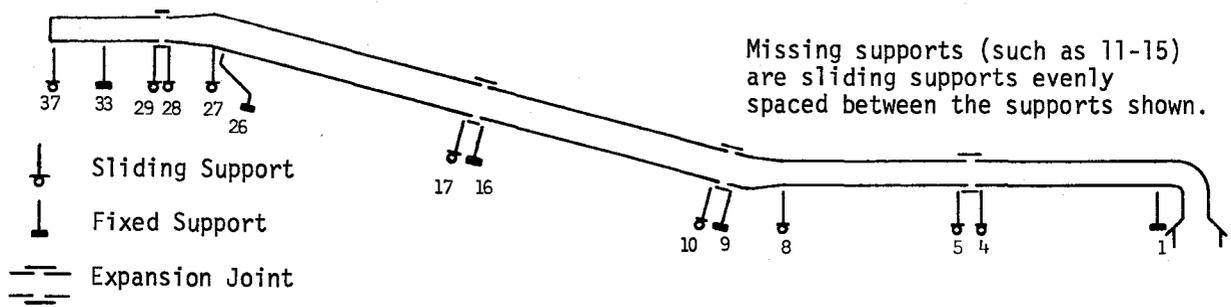
Fig. 2 - Schematic representation of the south duct showing supports and expansion joints.

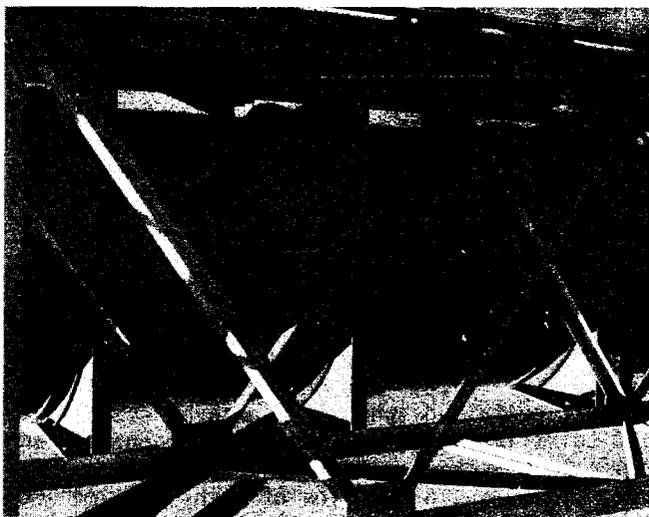
Fig. 3 - Bottom view of typical shell crack at stiffener ring

The source of the high thermal stresses was readily determined by examination of the failures and the geometry of the structure. Support rings on the outside of the duct were welded to the duct preventing free diametral thermal breathing of the duct. Large temperature differences between the rings and the duct produced large differential thermal expansions between the ring and the duct in both the radial and axial directions, resulting in large thermal stresses in the duct at the welds. Weather conditions (wind, rain, snow, darkness) caused changes in heat transfer from the outside surface of the duct, resulting in cyclic thermal stresses. Predictable variations in the gas temperature due to startup, normal operation, and shutdown of the furnace also caused cyclic thermal stresses. These cyclic stress conditions produced fatigue cracks in the duct. The fatigue cracks initiated near the stiffener rings, and propagated through the duct under the influence of the thermal stresses caused by the rings and the thermal bending stresses in the duct caused by the redundant supports.

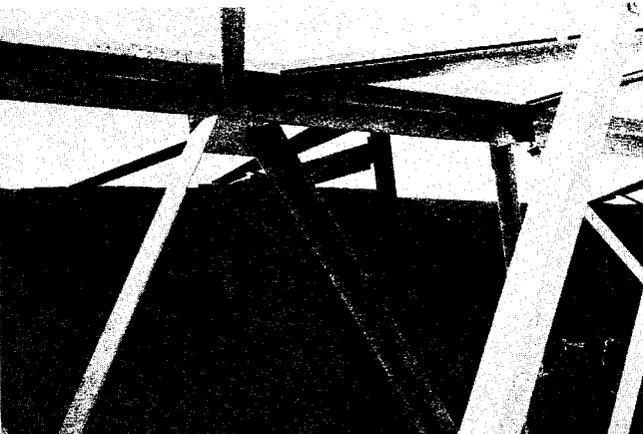
Fig. 4 - Bottom view of shell crack at stiffener ring which has propagated away from the ring

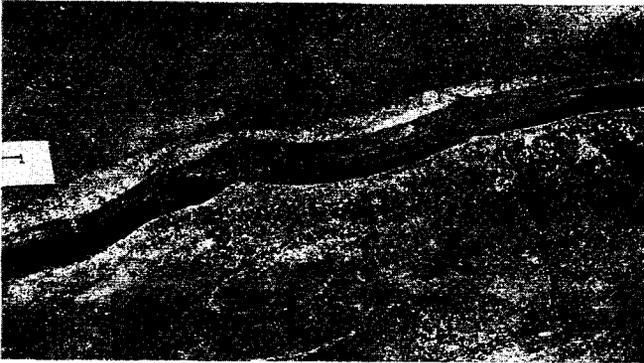
Fig. 6 - Open Crack at stiffener ring

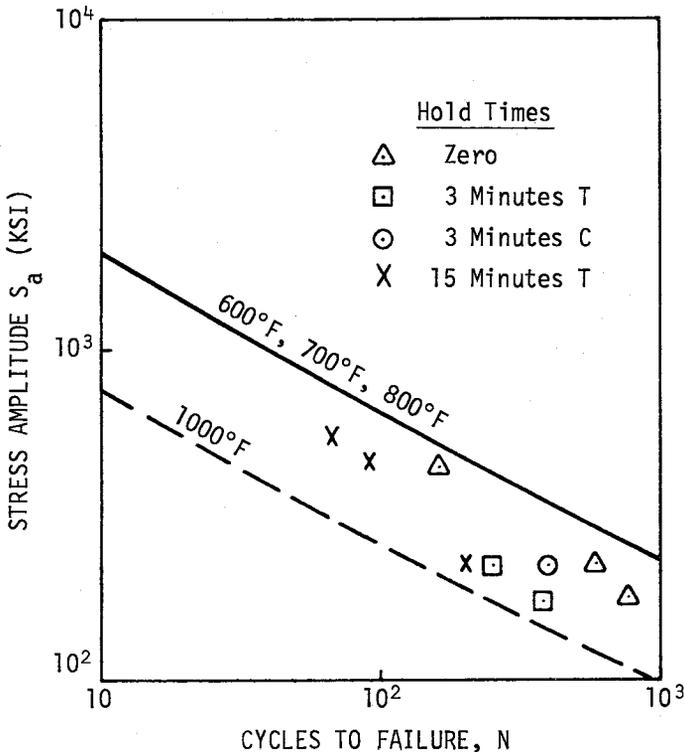
The resulting low cycle fatigue test data is plotted on Figure 9, along with the theoretical mean failure curves which had previously been derived using tensile test data reported by U. S. Steel. The theoretical failure curves were based on the Langer-Coffin equation which does not include consideration of creep effects. However, the use of a relatively low reduction in area value of 34 percent was believed to account for the reduced ductility due to thermal aging and creep effects at 1000°F. Note that all of the fatigue test data falls between the theoretical failure curves for 370°C and 540°C (700°F and 1000°F),

Fig. 9 - Low cycle fatigue test data

respectively. Thus, the fatigue test results indicate that the fatigue properties of COR-TEN steel are much lower at 1000°F than at 600, 700 or 800°F. Moreover, the data substantiates the validity of the fatigue properties used.

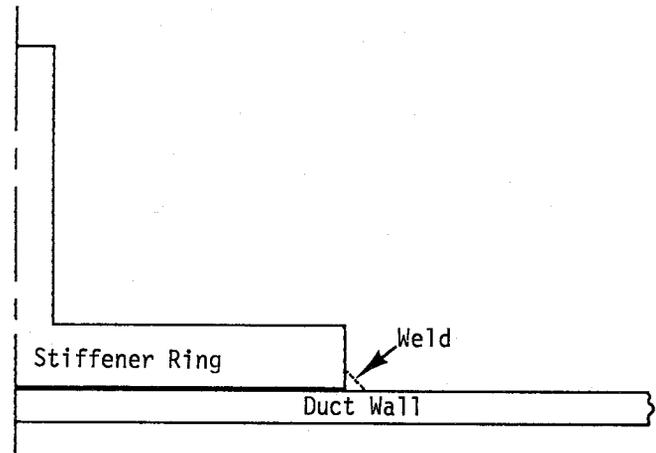
Fig. 10 - Stiffener ring welded to duct

The computer model illustrated on Figures 10 and 11 shows a gap between the duct and the stiffener ring. Field measurements show that

this gap, which resulted from the fabrication process, varied from a minimum (usually direct contact) near the bottom of the duct to a maximum near the top of the duct. The gap is also larger at the welded edges of the ring than at the center of the ring due to the permanent anticlastic curvature introduced when the rings were fabricated. The maximum gap varied from ring to ring. A series of thermal problems were run with the gap thickness varied from zero to 2.54 cm (1 in.). The reference problem has a 0.119 cm (0.0469 in.) gap considered representative of the "typical" gap thickness around the circumference.

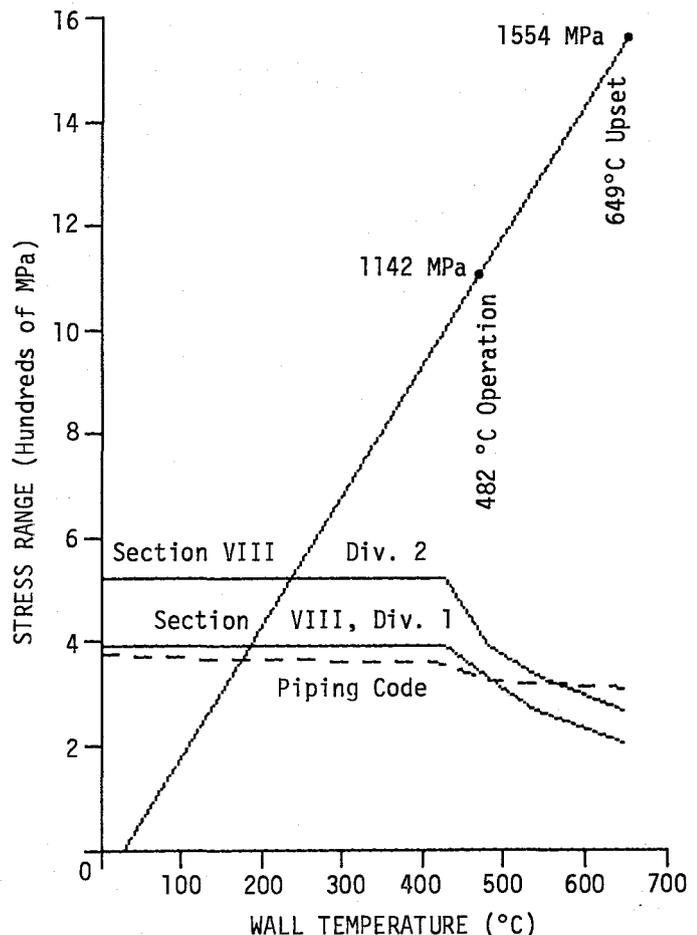
Fig. 12 - Comparison of elastically calculated stress range to limits imposed by Codes

COR-TEN steel is not an ASME Boiler and Pressure Vessel Code material. However, the basis for establishing  $S_m$  described in Section VIII, Division 1 and that described in Section VIII, Division 2 of the Code were used to determine stress range limits for thermal stresses in this application. The allowable stress range formula for expansion stresses given in paragraph 102.3.2C of the ANSI B31.1 Piping Code was also considered. As can be seen on Figure 12, by the time the duct wall temperature goes above 233°C (452°F), the allowable stress range has been exceeded for all three of these approaches. Normal anticipated operation and the occasional upset condition produced elastically calculated stresses far above these limits.
