# LOW CYCLE THERMAL FATIGUE AND FRACTURE OF REINFORCED PIPING

**W.J. O'Donnell, J.M. Watson**

## ABSTRACT

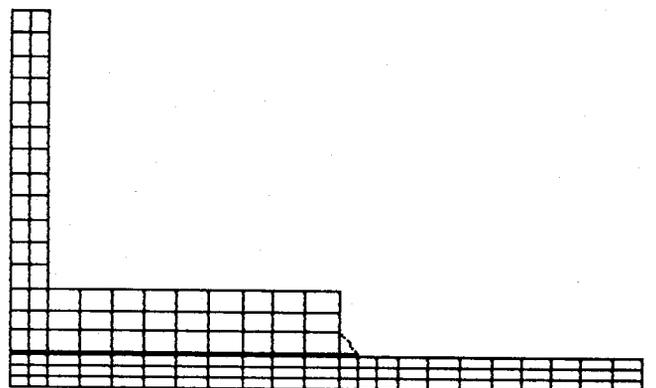
Fig. 11 - Finite element model of ring/duct interface

The computer model illustrated on Figures 10 and 11 shows a gap between the duct and the stiffener ring. Field measurements show that
